PHASE I REPORT
NATIONAL DAM INSPECTION PROGRAM

NAME OF DAM: Chamberlain Pond Dam
STATE LOCATED: Pennsylvania
COUNTY LOCATED: Wyoming
STREAM: Little Mehoopany Creek, tributary of the Susquehanna River
SIZE CLASSIFICATION: Small
HAZARD CLASSIFICATION: High
OWNER: Mr. Robert Witlock
DATE OF INSPECTION: November 12, 1980 and February 4, 1981

CHAMBERLAIN POND DAM
NDI I.D. PA-0890
DER I.D. 066-011
NOVEMBER 12, 1980

PHASE I REPORT
NATIONAL DAM INSPECTION PROGRAM
CHAMBERLAIN POND DAM
NDI I.D. PA-0890
DER I.D. 066-011

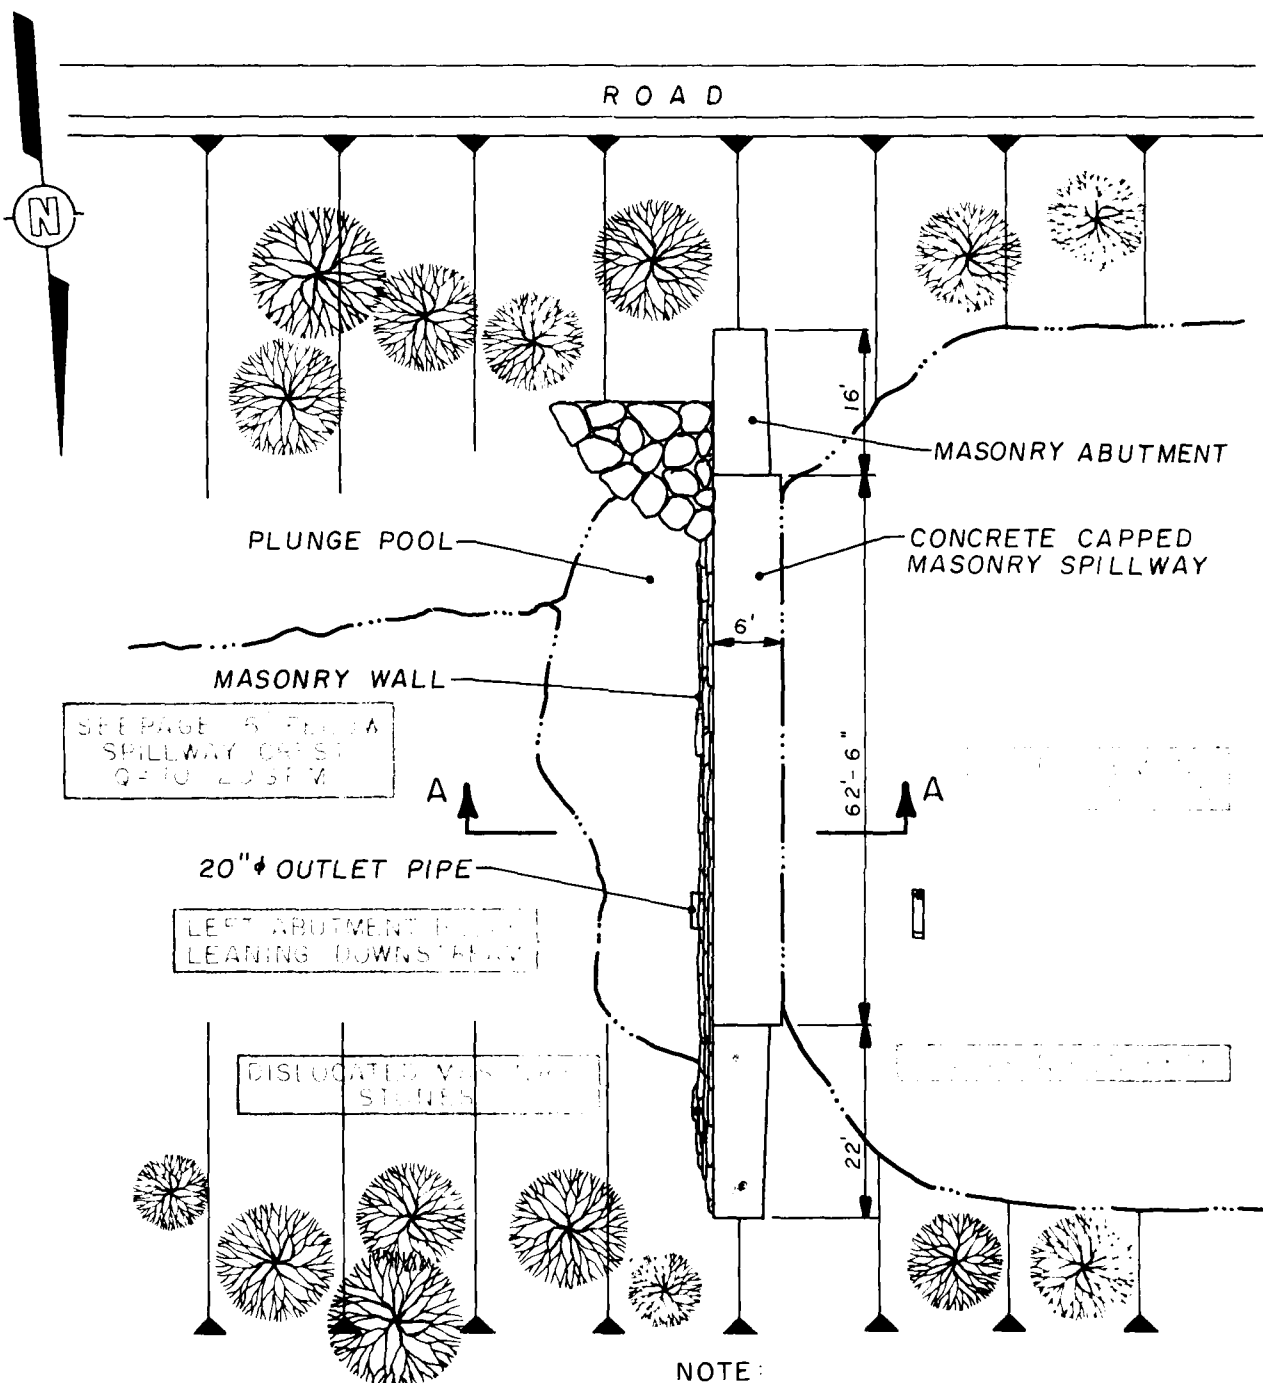
PLATE 2
 CHAMBERLAIN POND DAM
 GENERAL PLAN
 FIELD INSPECTION NOTES
 FIELD INSPECTION DATE: NOV. 12, 1980

NOTE:
 POOL LEVEL AT DATE OF INSPECTION:
 1.3' BELOW SPILLWAY CREST
